# Navajo Abandoned Uranium Mine Site Screen Report

## **Dakota AUM Site**

## **Navajo AUM Eastern Region**

**May 2009**

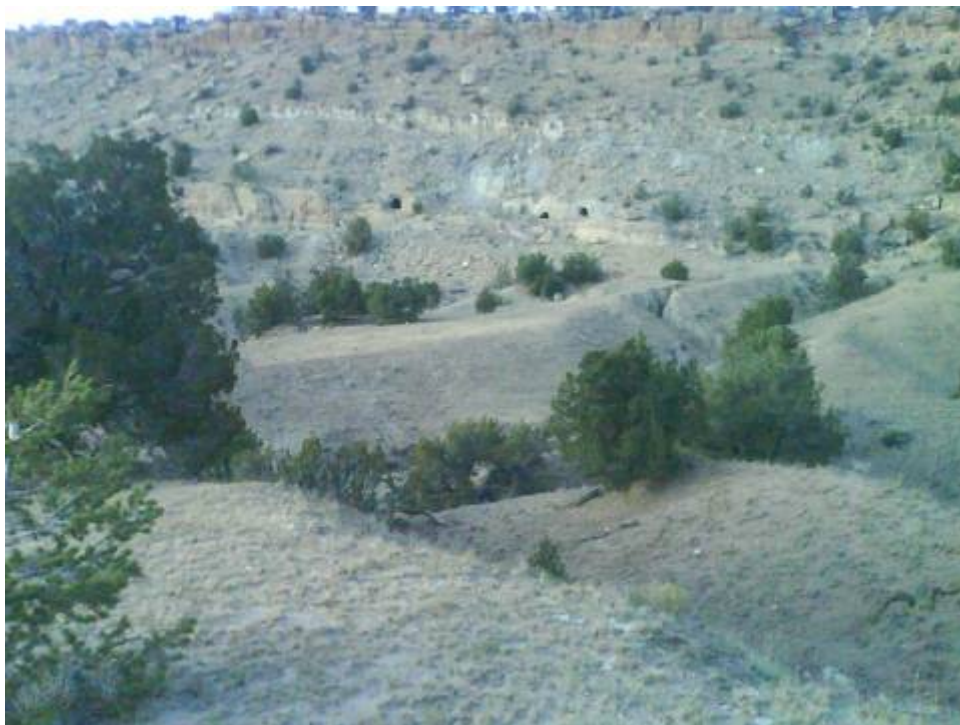
Photo 1. Dakota Mine site, towards the north

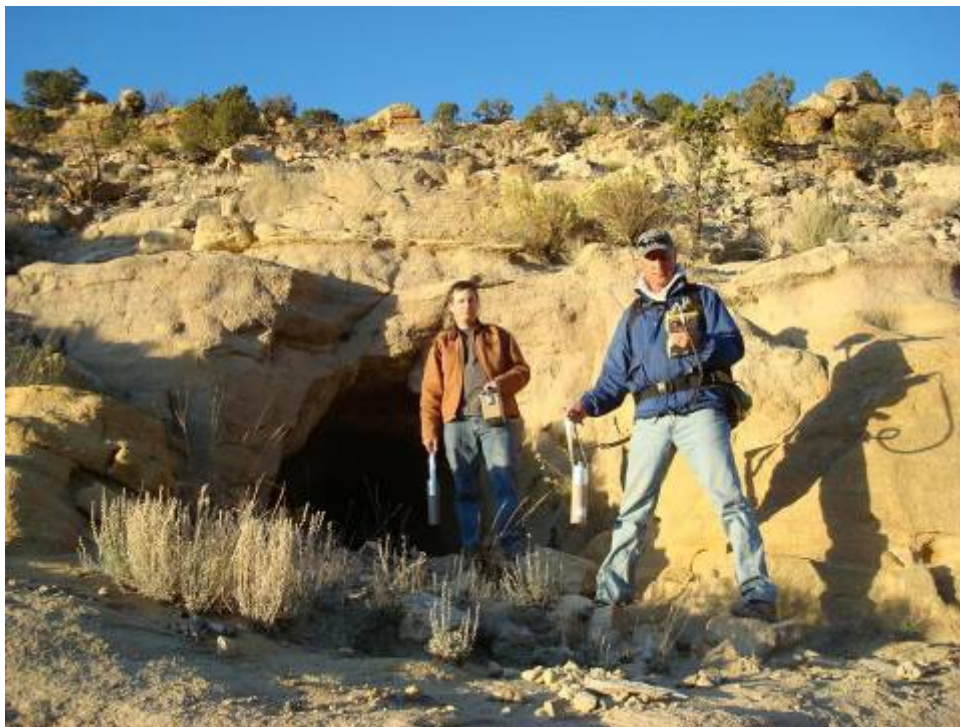
Photo 2. Dakota Mine site, adit in hillside

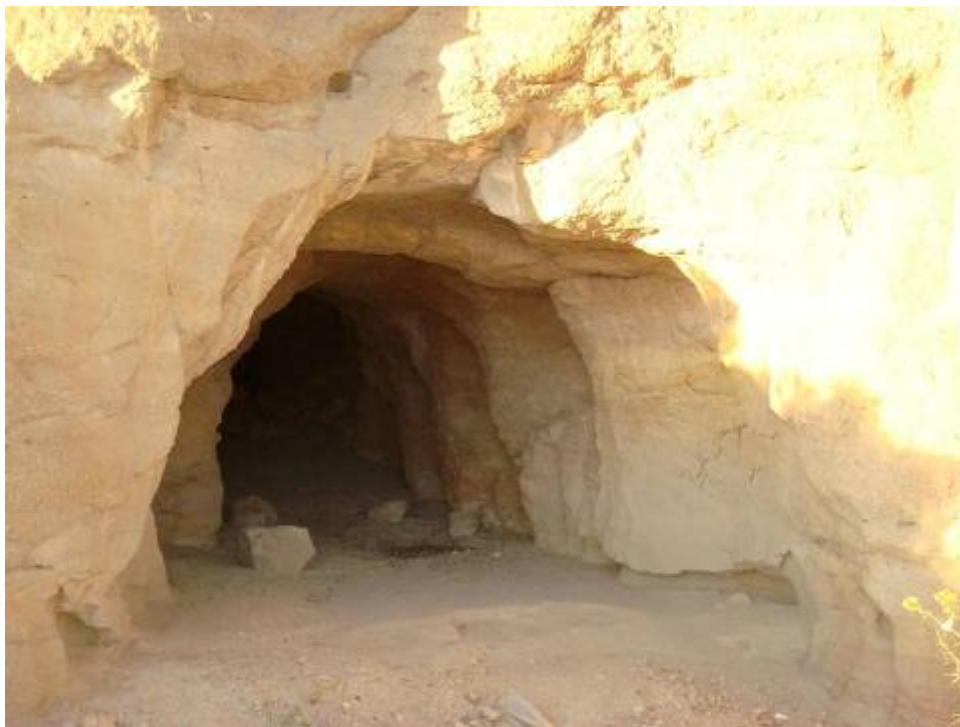
Photo 3. Dakota Mine site, adit in hillside

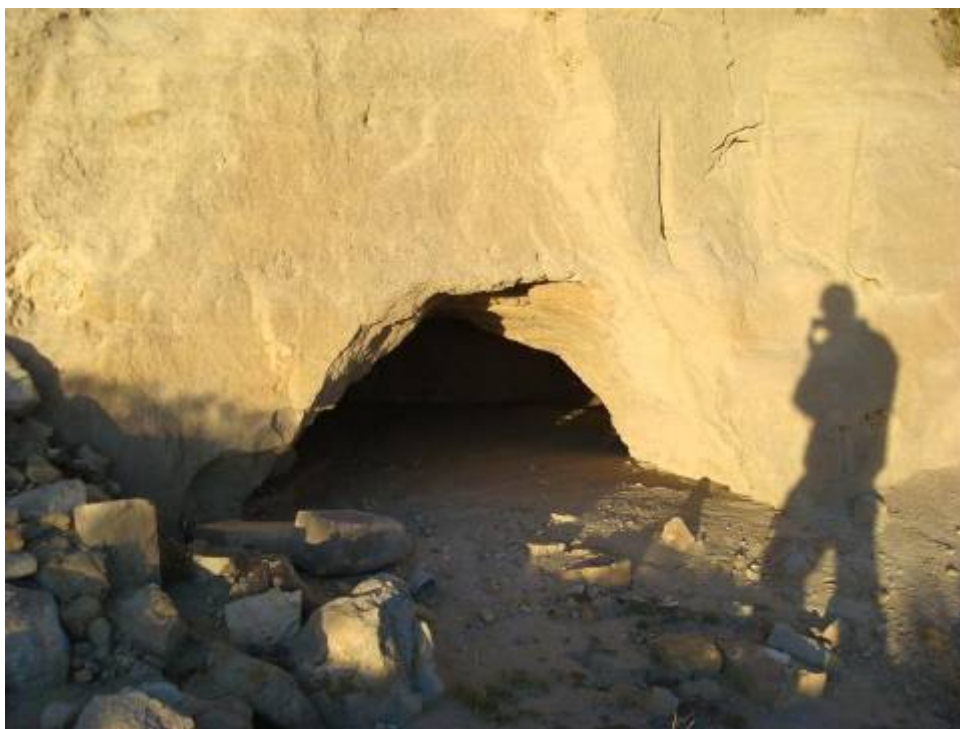
Photo 4. Dakota Mine site, adit in hillside

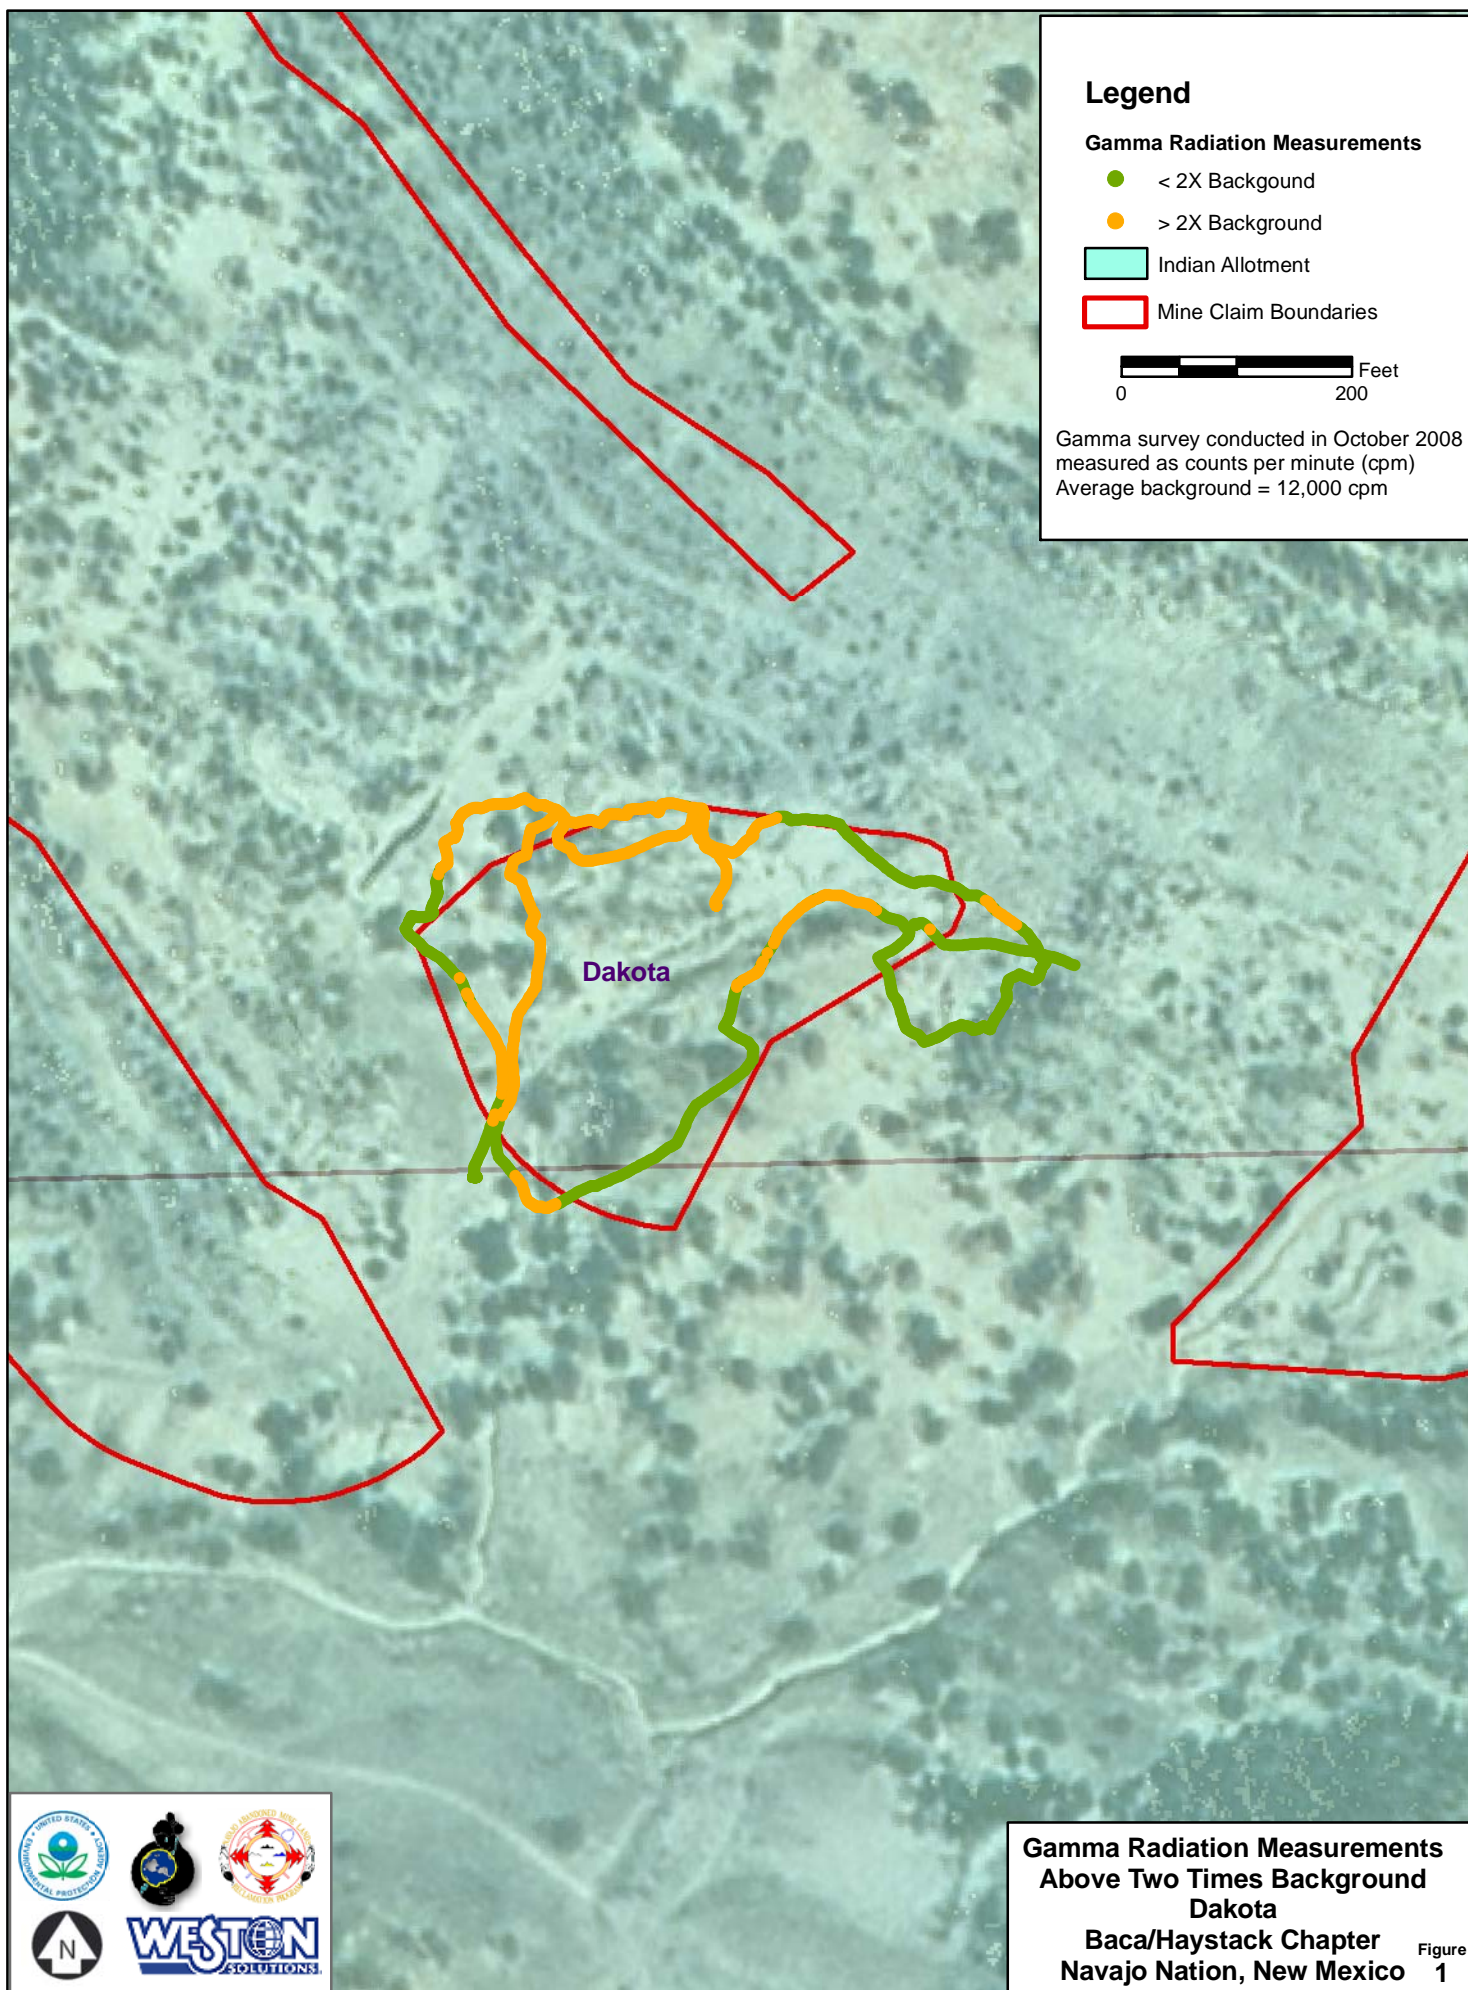
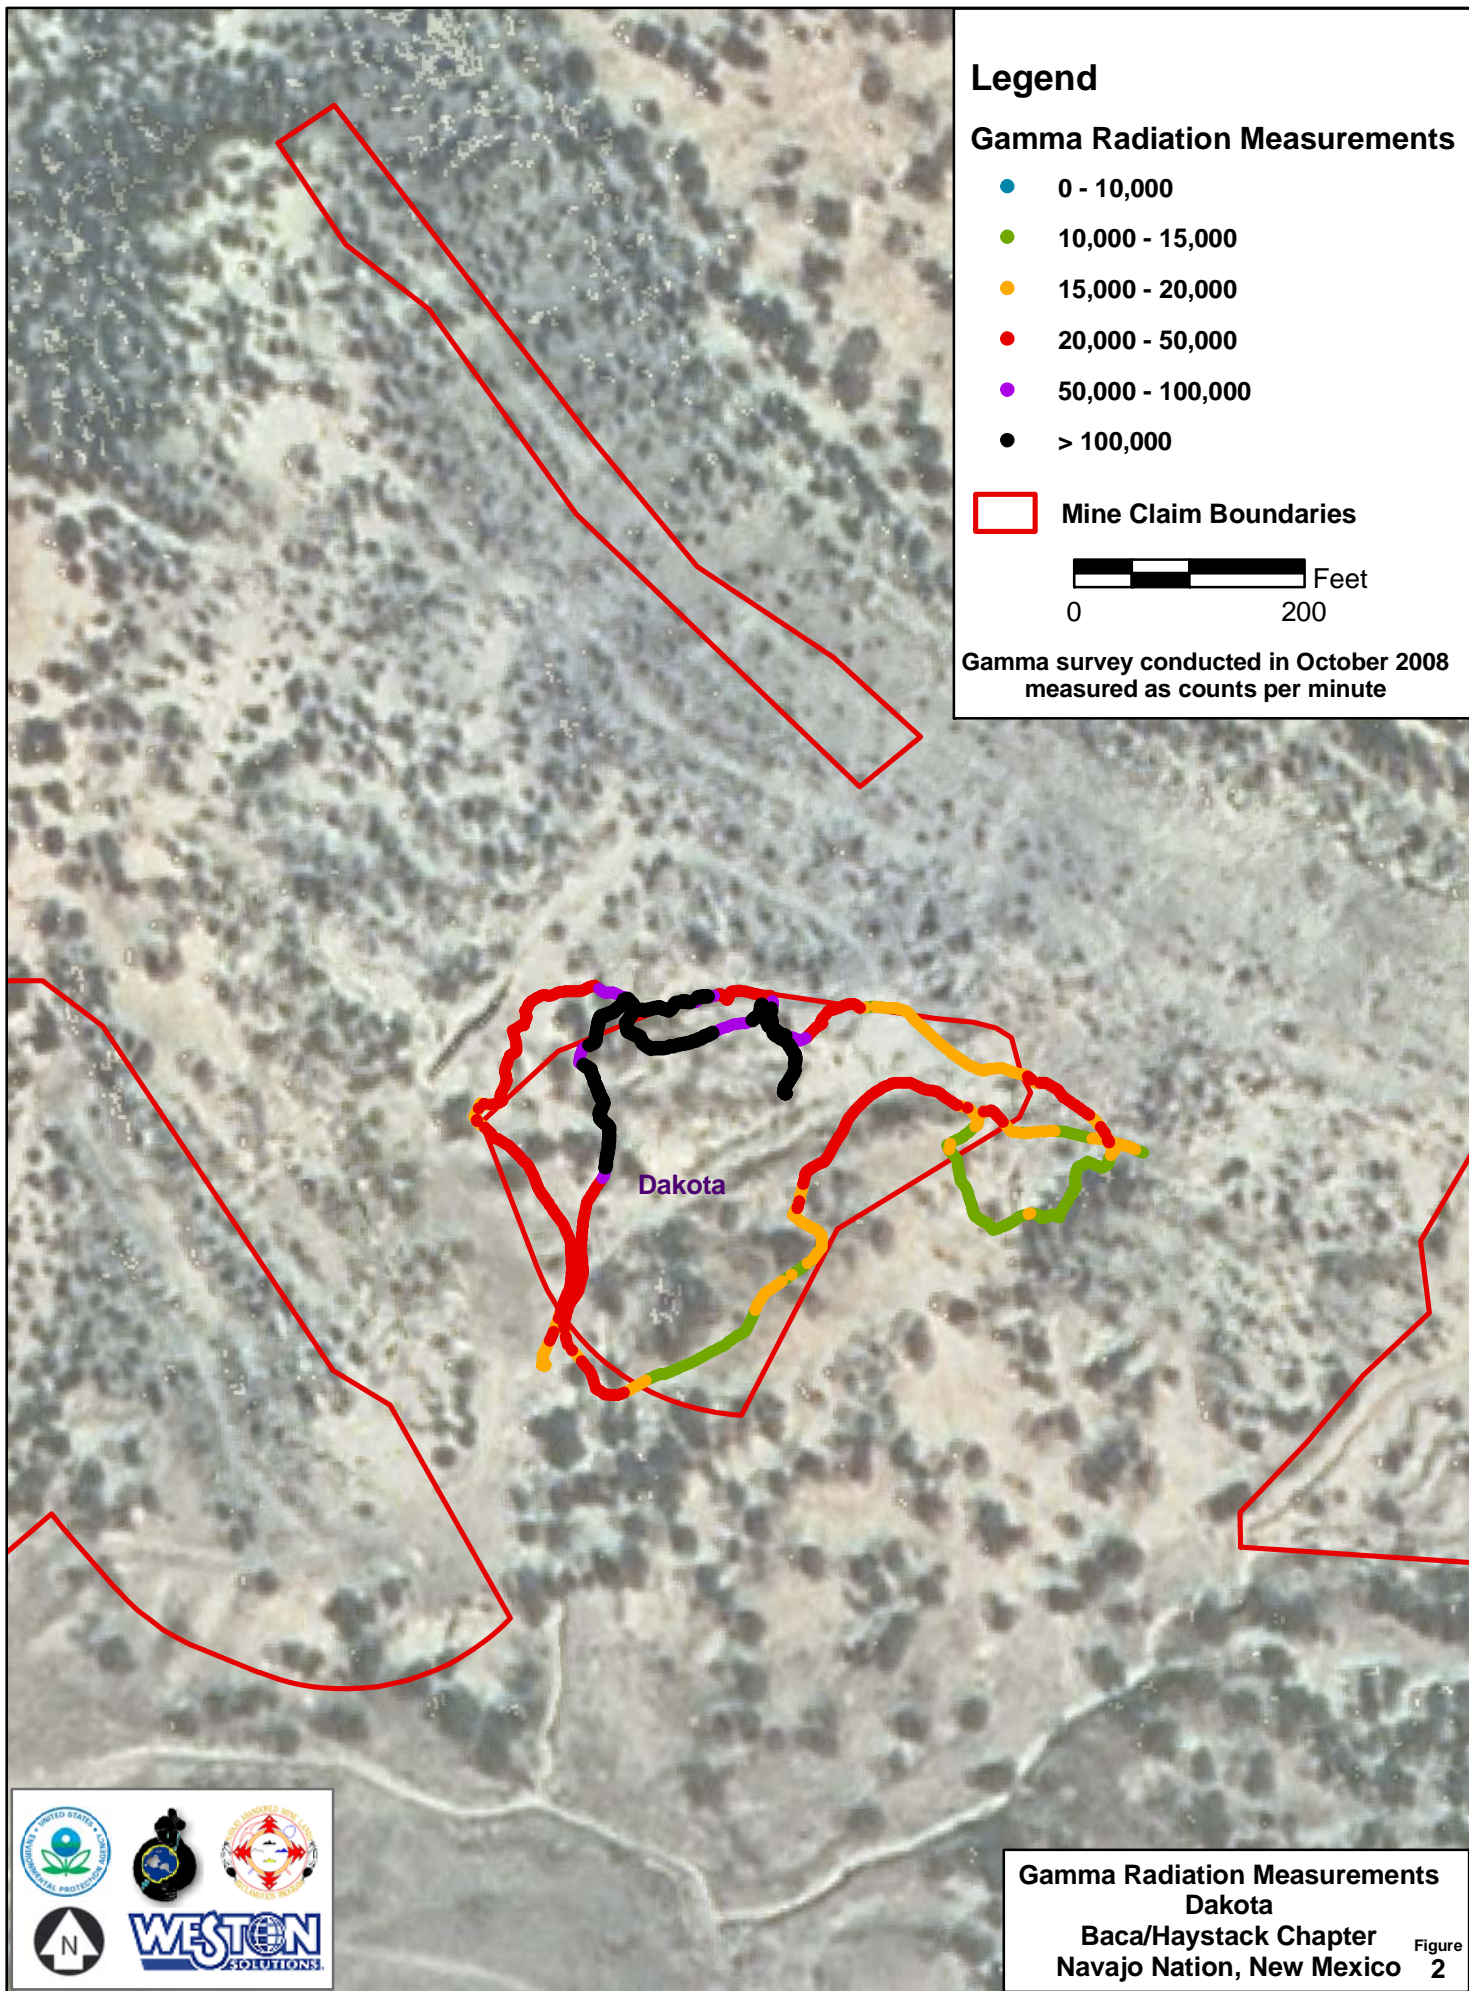
A total of 1,178 gamma radiation measurements were collected from the mine site, ranging from 9,810 cpm to 292,715 cpm. Gamma radiation measurements at the mine adits were as great as 650,000 cpm. The measurements are represented in Figures 1 and 2. The New Mexico Mining and Minerals Division identified radiological measurements with background levels 50 counts per second (cps); and a high of 500 cps.
